The Impact of Reflowing A Pbfree Solder Alloy Using A Tin/Lead Solder Alloy Reflow Profile On Solder Joint Integrity

David Hillman, Matt Wells, Kim Cho
Rockwell Collins
Cedar Rapids Iowa USA

The objective of the study was to evaluate the solder joint integrity impact of reflowing a Pbfree solder alloy using a tin/lead reflow profile on BGA components.

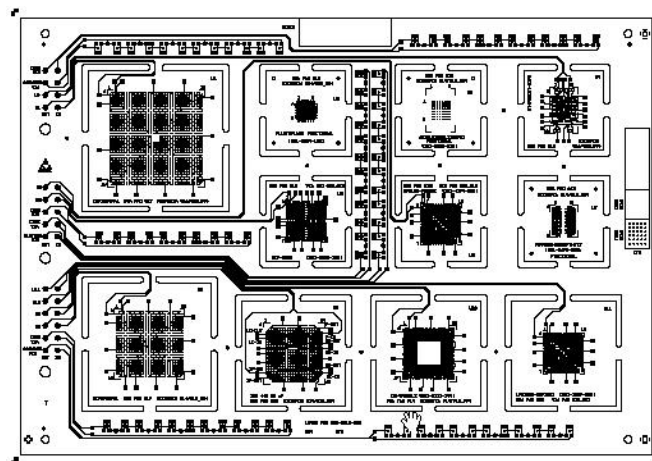
Figure 1: Test Vehicle Design

The test vehicle used in the investigation was 0.082 inches thick, contained 18 layers of 0.5 ounce copper, and used an electroless nickel/immersion gold (ENIG) finish. The test vehicle laminate was FR4 per IPC-4101/26 with a minimum Tg of 170°C. The test vehicle contained 11 component test locations. Figure 1 illustrates the test vehicle design.

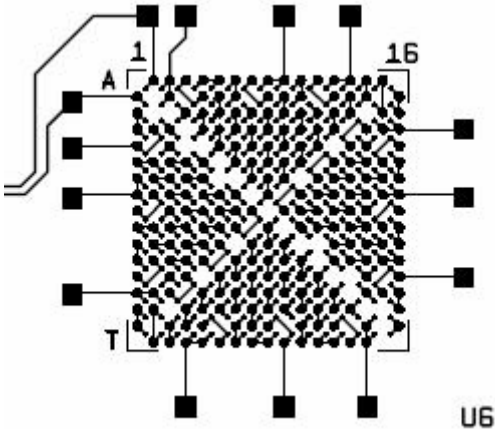
Figure 2: Test Component Pad Pattern

The test component was an 256 Daisy Chained, I/O 256, 17mm x 17mm square, 1.0 mm pitch Field Programmable Gate Array utilizing a Sn/4.0Ag/0.5Cu (SAC 405) soldersphere alloy. The BGA component was originally to

have tin/lead solderballs but was unintentionally supplied with Tin/Silver/Copper (SAC) solderballs. Process time constraints did not allow for the component supplier to replace the BGAs with Sn/Pb solderballs thus allowing the opportunity to investigate the interaction of a SAC solder alloy with a Sn/Pb soldering reflow process. Figure 2 illustrates the test component pwb pad pattern.

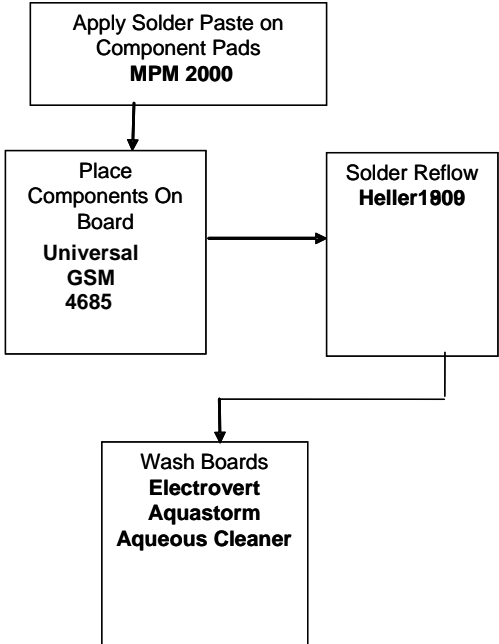
Figure 3: Flow chart of assembly process

The test vehicles were processed as shown in the flow diagram in Figure 3.

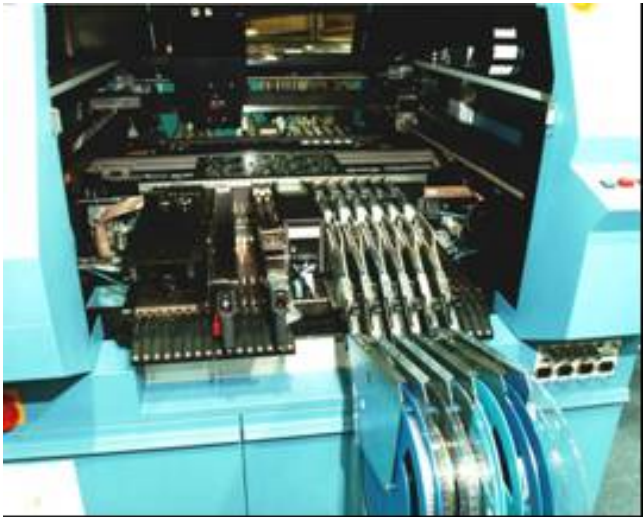
Figure 4: Universal GSM 4685 Machine

The test vehicles were immediately transferred to the Universal GSM 4685 machine shown in Figure 4 upon completion of the application of solder paste. The test vehicles were fully populated.

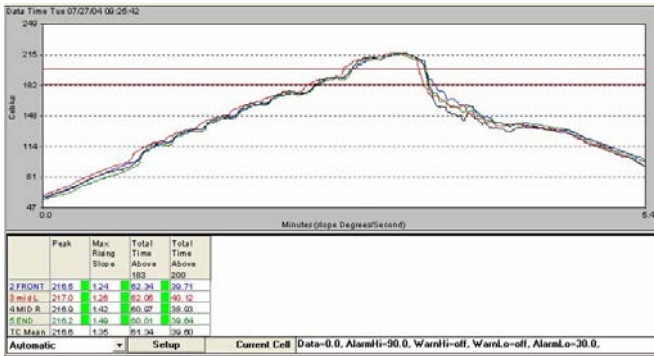
Figure 5: Thermal Profile

The test vehicle was reflowed with a Heller 1809EXL Convection Reflow Oven. This oven had ten temperature zones for solder reflow. The conveyor speed was 34 inches per minute and the nitrogen flow was 1500 cubic feet per hour (approximately 150ppm O₂ concentration). The oven used the high convection setting, and the boards were placed on the rails. The reflow profile as measured on the test vehicle is shown in Figure 5.

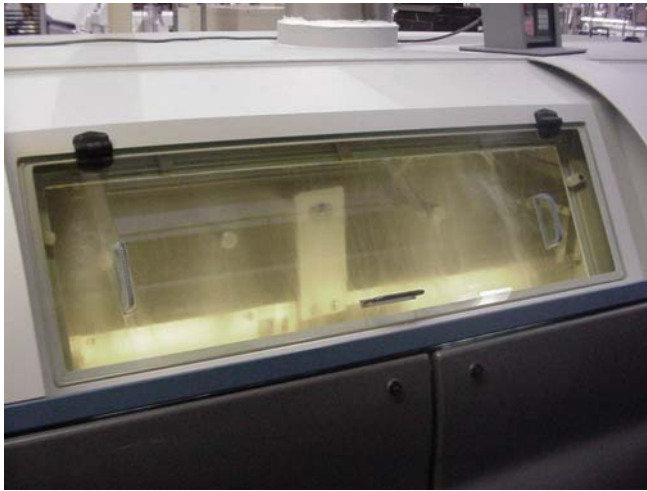
Figure 6: Inline Cleaning System

The boards were allowed to cool to room temperature after reflow and then placed an Electrovert Aquastorm in-line cleaning system for removal of solder flux residues. The in-line cleaner utilized Kyzen SSA saponifier/de-ionized water to remove the test vehicle flux residues. The in-line cleaner is shown in Figure 6.

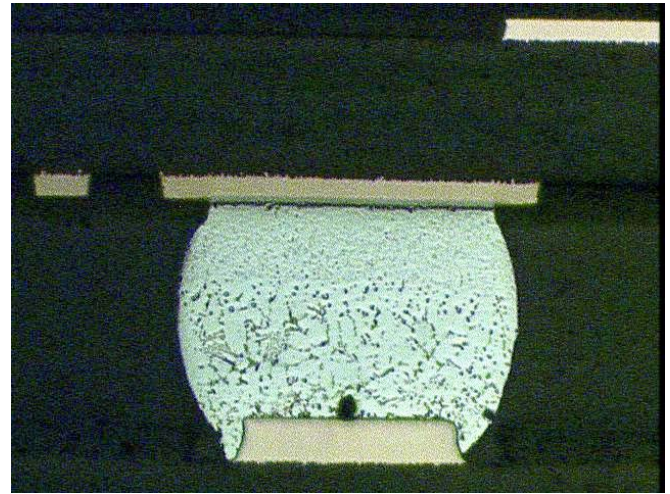
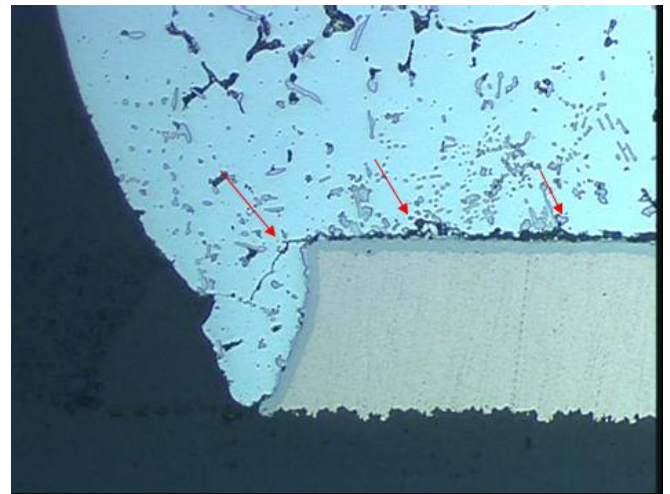
The test results indicated the first BGA solder joint failures occurred after 137 thermal cycles with a 276 thermal cycle

population average being recorded. Typical BGA solder joint failures measured during other area array component investigations [1] has been in the 1000-2000 thermal cycle range. Metallographic analysis was conducted to determine solder joint failure characteristics. Figures 7 and 8 illustrates the BGA solder joint failure observed during the metallographic analysis. The red arrows in Figure 8 point to the solder joint crack.

Figure 7: Macro View of BGA Solder Joint Failure

Figure 8: Magnified View of BGA Solder Joint Crack

The BGA solder joint failure is non-typical in a number of ways: (1) a solder joint failure at 137 thermal cycles would be considered premature and an indication of either a component fabrication or manufacturing error; (2) the solder joint crack was located at the solderball/pwb pad side of the solder joint – typical BGA solder joint cracks are located at the solderball/component pad side; (3) the solder joint crack was located at the solder matrix/solder joint intermetallic interface – typical solder joint crack location is in the solder matrix. Inspection of the solder joint revealed four distinct regions of differing microstructure. Each region has been designated as a Zone (A-D) for ease of discussion. Figure 9 illustrates the zones and Table 1 lists the microstructure observed in each zone.

Area array components (ball grid arrays, chip scale packages, flip chip packages) with Pbfree solder sphere alloys should not be reflowed using a tin/lead reflow profile due to the resulting non-uniform solder joint microstructure and potential poor board surface finish wetting interactions.

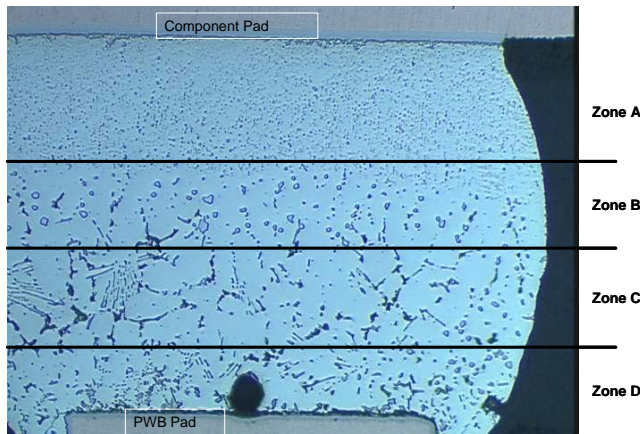
Figure 9: BGA Solder Joint Microstructure Zones

Zone	Microstructure Observed
A	Original SAC solderball - Tin Matrix, Fine Blocky & Platelet Intermetallic Phases
B	Tin Matrix, Large Blocky & Platelet Intermetallic Phases
C	Tin Dendrite Matrix, Interdendritic Phases, Fine Blocky & Platelet Intermetallic Phases
D	Tin Dendrite Matrix, Interdendritic Phases, Blocky & Platelet Intermetallic Phases, Solder Joint Crack

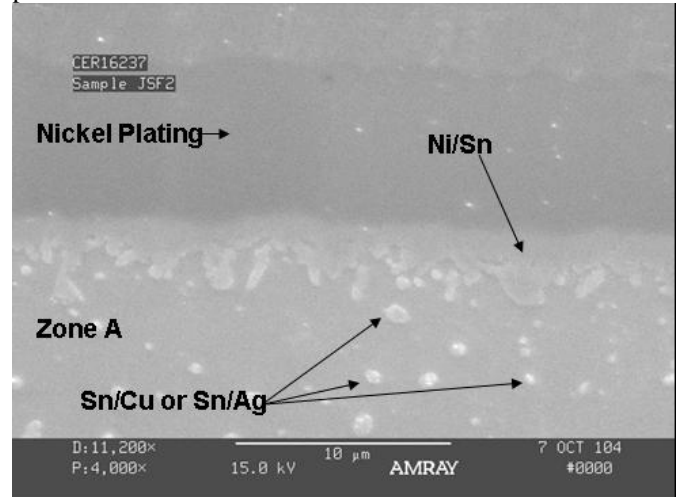
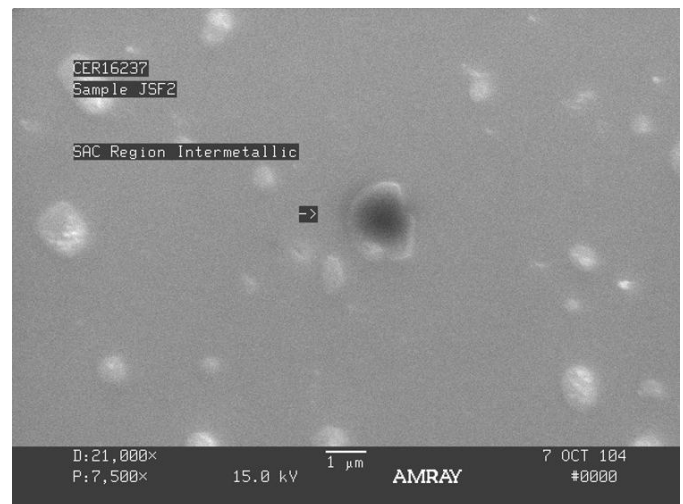
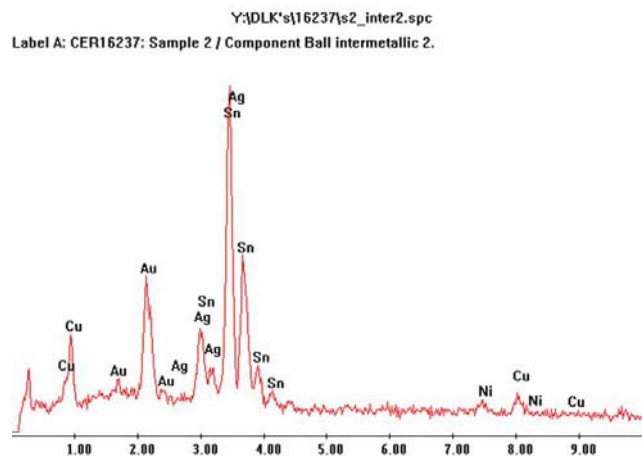
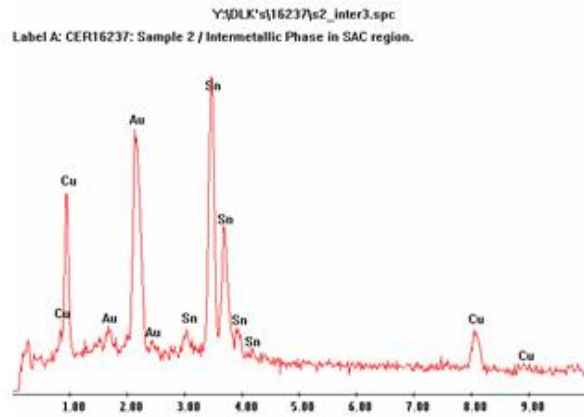
The BGA solder joint zone A region was the farthest zone from the Sn63/Pb37 solder paste deposit and retained its original SAC solder microstructure. The component pad was a gold/nickel finish prior to SAC solderball attachment by the component fabricator. A tin matrix was present as expected for a SAC solder alloy. SEM EDX scanning found the fine blocky intermetallic phases to be composed of either tin/copper (Sn/Cu) or tin/silver (Sn/Ag). A nickel/tin (Ni/Sn) intermetallic phase was also identified at the solder/component pad interface as expected. The intermetallic phases were identified as Cu_6Sn_5 , Ag_3Sn , and Ni_3Sn_4 in agreement with other industry studies [2, 3]. Some joints showed large platelets of Ag_3Sn intermetallic phase. Figures 10-13 illustrate the microstructure phases identified

in zone A and SEM EDX scans of those microstructure phases.

Figure 10: Zone A Microstructure Phases

Figure 11: Zone A Fine Blocky Phases

Figure 12: SEM EDX Scan of Sn/Ag Phase

Figure 13: SEM EDX Scan of Sn/Cu Phase

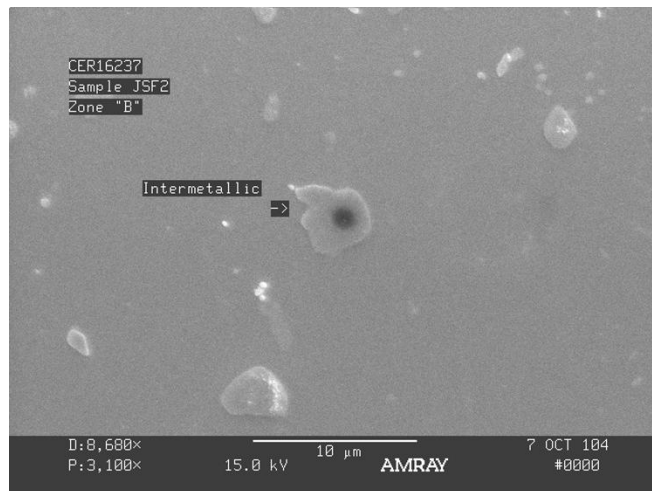
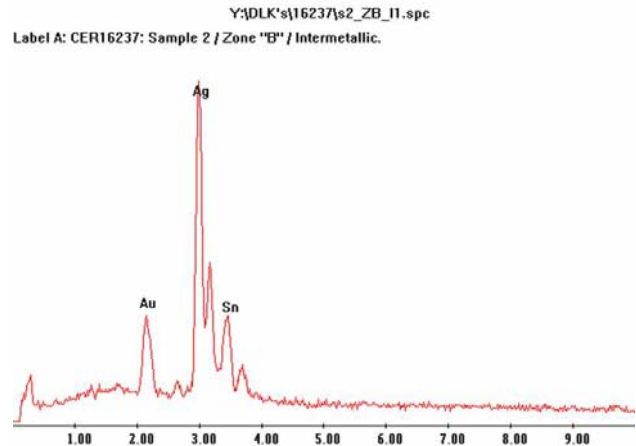
A tin matrix is still present in Zone B of the BGA solder joint. Zone B shows the following changes: the fine blocky intermetallic phases were replaced with large blocky intermetallic phases; the intermetallic phases were identified as Cu_6Sn_5 , Ag_3Sn , - no Ni_3Sn_4 was identified. Figures 14-15 illustrates the Ag/Sn microstructure phase identified in zone B and SEM EDX scans of that microstructure phase.

Figure 14: Zone B Large Blocky Phases

Figure 15: SEM EDX Scan of Sn/Ag Phase

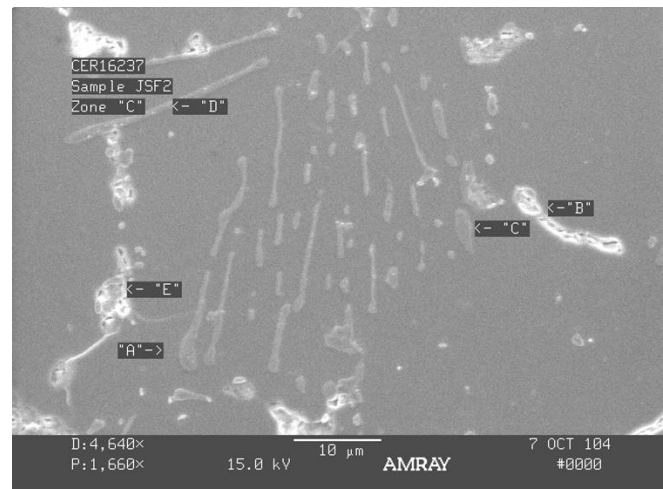
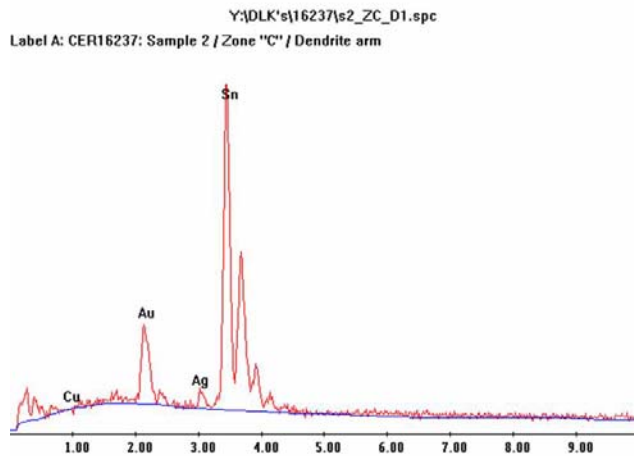
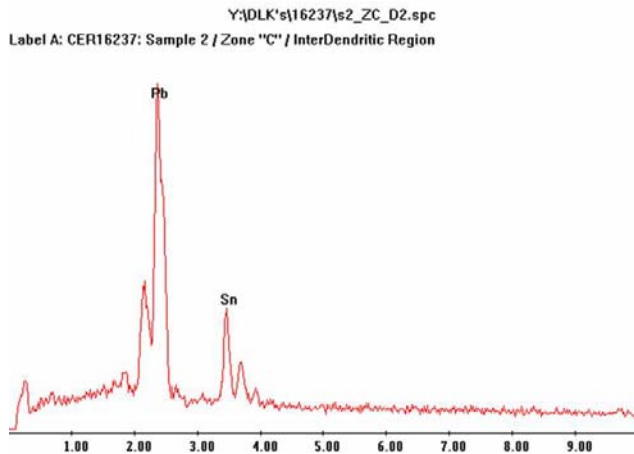
The BGA solder joint zone C region had undergone significant microstructural change. The tin matrix observed in Zones A and B changed to dendritic solidification in Zone C. The large blocky intermetallic phases were identified as Cu_6Sn_5 and Ag_3Sn . A fine platelet intermetallic phase (Ag_3Sn) was observed and a 96.5Sn/3.5Ag eutectic phase was found in the interdendritic regions. Additionally, the first indication of the Pb from the 63Sn/37Pb solder paste deposit was identified in the interdendritic regions. Figures 16-18 illustrate the microstructure phases identified and SEM EDX scans of the zone C microstructure phases.

Figure 16: Zone C Microstructure: "A" - Sn/Ag Platelet, "B" - Pb Interdendritic Region, "C" - Sn/Ag Blocky Phase, "D" - Sn/Ag Platelet, "E" - Pb Interdendritic Region

Figure 17: SEM EDX of Dendrite Phase

Figure 18: SEM EDX of Interdendritic Region

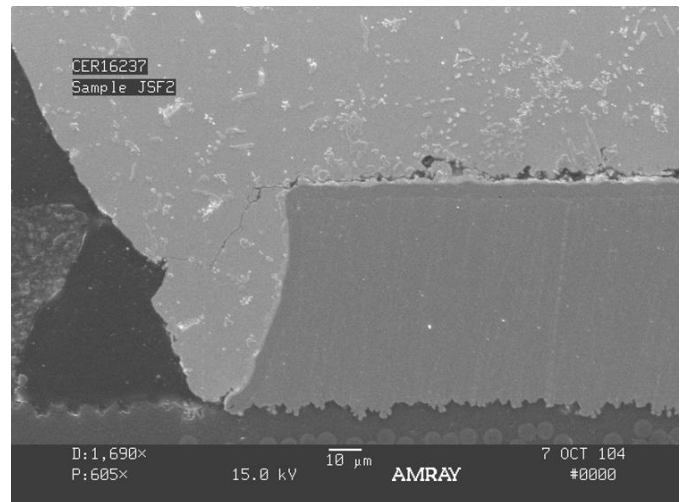
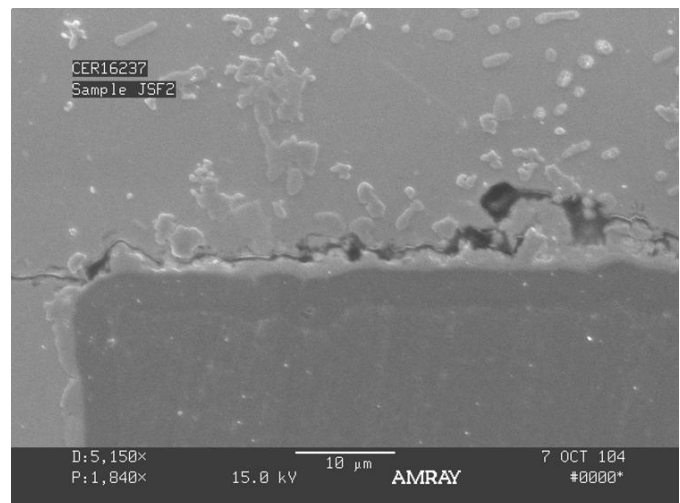
The BGA solder joint zone D region was the zone directly in contact with the 63Sn/37Pb solder paste deposit. Zone D is a region composed of tin matrix, sporadic tin dendrite occurrence, platelet and blocky intermetallics, regions of Pb, and the solder/pwb pad interface. A Ni/Sn intermetallic phase was present due to the use of the ENIG pwb finish. Figures 19 and 20 illustrate the solder joint crack and the microstructure phases in zone D.

Figure 19: Zone D Solder Joint Crack and Phases

Figure 20: Magnified View of Solder Joint Crack

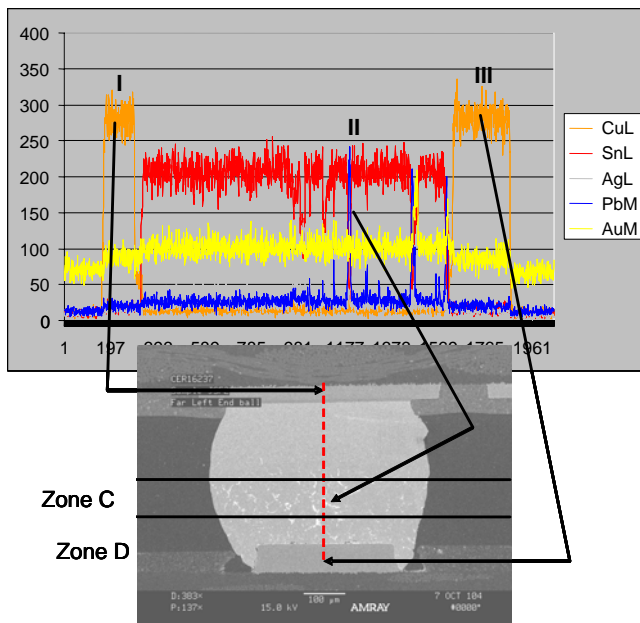
Several SEM EDX line scans were completed to determine the elemental constituent change across a region in contrast to the SEM EDX measurements taken of specific microstructure phases. Figure 21 illustrates a line scan across a BGA solder joint. The component and pwb copper pads are very evident at the beginning and end of the line scan. A large Pb peak was also recorded as the line scan traversed across an interdendritic region in zone C.

Figure 21: SEM EDX Line scan of BGA Solder Joint; (I) Copper of Component Pad; (II) Lead in Interdendritic Region; (III) Copper of PWB Pad. X axis is the scan distance and the Y axis is the elemental count scale.

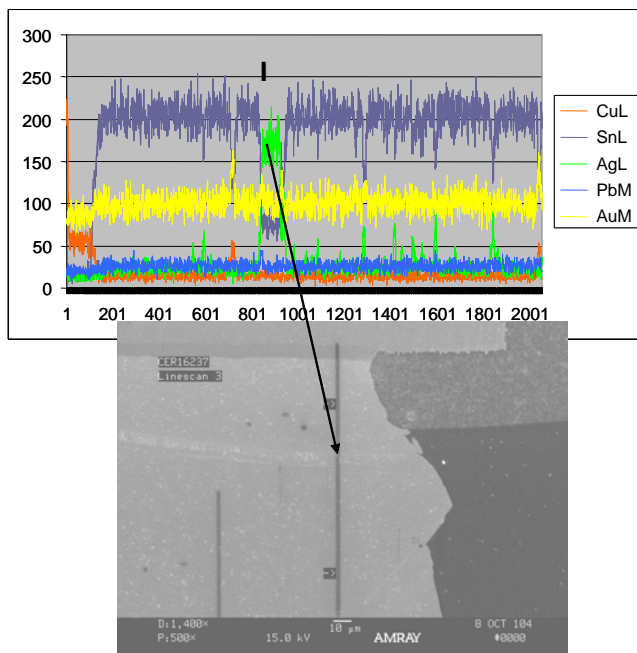
A line scan traversing a large platelet phase produced a large silver peak complementing the SEM EDX specific phase measurements defining the structure as Ag_3Sn intermetallic (see Figure 22).

Figure 22: Ag_3Sn Intermetallic Indication By SEM EDX Line scan; (I) Silver Peak Upon Traversing Large Platelet Microstructure Phase. X axis is the scan distance and the Y axis is the elemental count scale.

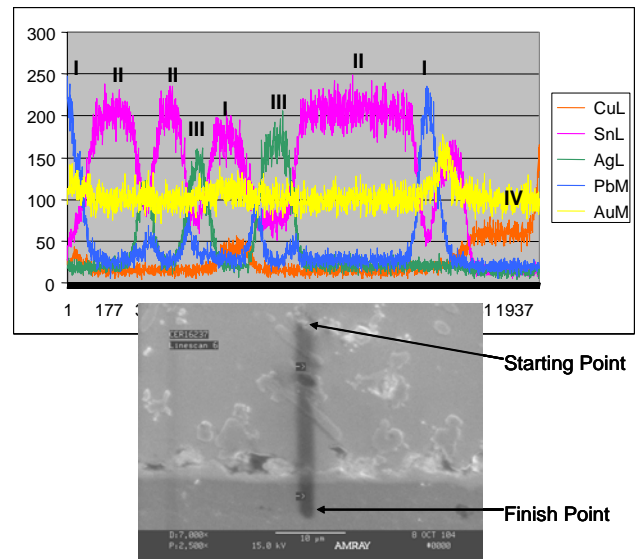
A SEM EDX line scan was completed traversing the solder joint crack in Zone D. The measurements indicated Pb in the interdendritic regions and the solder joint/pwb pad interface, Ag_3Sn intermetallic phase, and the tin microstructure matrix. Figure 23 illustrates these line scan results.

Figure 23: SEM EDX Line scan; (I) Lead Peak; (II) Tin Peak; (III) Silver Peak; (IV) Copper Peak. X axis is the scan distance and the Y axis is the elemental count scale.

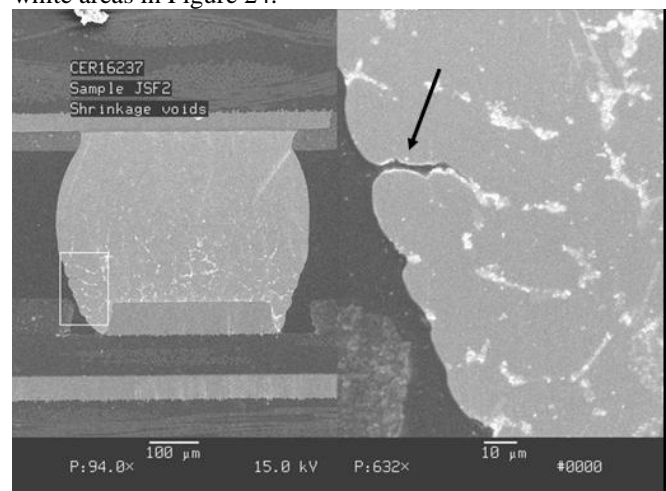
Two other microstructure observations were made during the SEM analysis: the presence of shrinkage voids and large intermetallic platelet phases. The shrinkage voids observed were associated with the formation of the tin dendritic matrix and are the result of solder solidification. The voids are not associated with Kirkendal voiding phenomena. Thermal cycling did not induce or propagate the shrinkage voids into cracks. Other industry investigations [2, 4] have documented similar results for the shrinkage voids. Figure 24 illustrates a typical shrinkage void found in the BGA solder joints. The segregation of Pb from the 63Sn/37Pb solderpaste is clearly visible in the interdendritic regions as white areas in Figure 24.

Figure 24: Shrinkage Void (arrow)

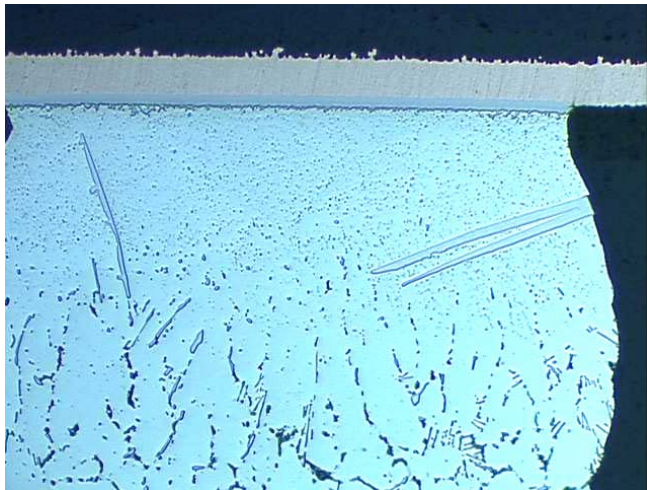
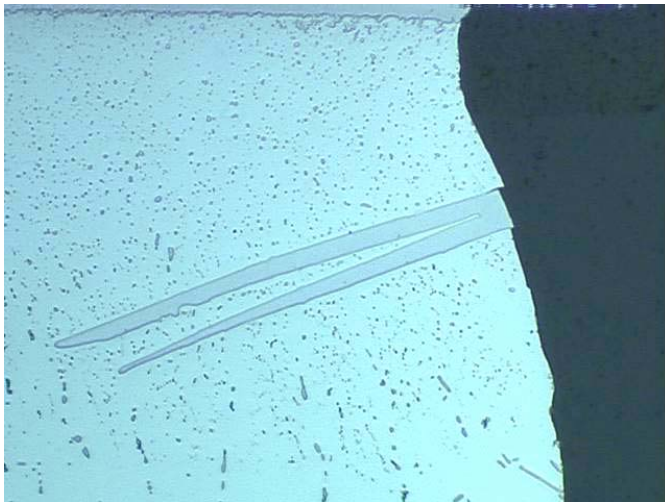
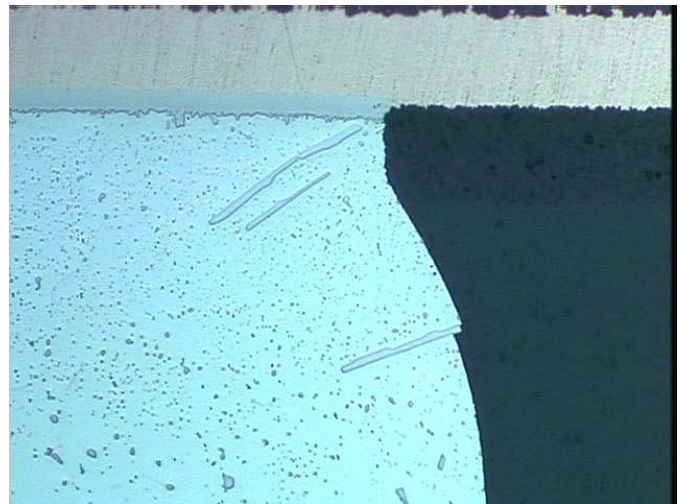
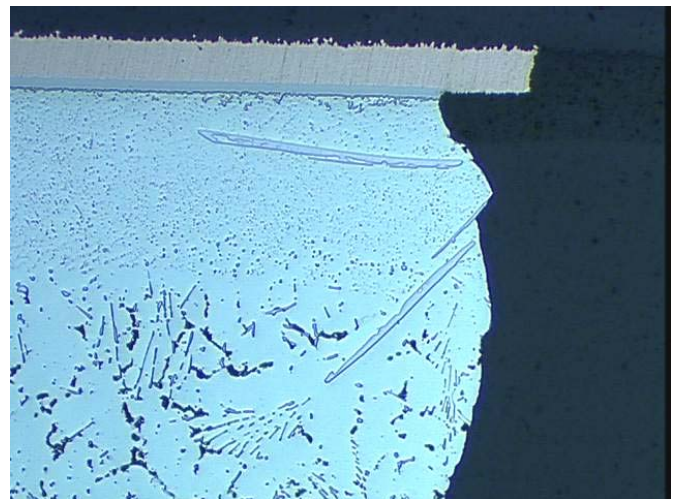
The presence of a large platelet intermetallic phase was observed during the metallographic analysis. Their solder joint location was predominately in zones A and B. SEM EDX analysis revealed these large platelets to be the Ag_3Sn intermetallic phase. A number of occurrences were documented where these platelets intercepted the BGA solder joint surface disrupting the solderball shape. Thermal cycling did not induce or propagate any cracking at/along the length of the large platelets. Other studies have observed similar large platelet intermetallic phases [2, 5, 6]. One industry investigation [7] purposed that the large platelet intermetallic phase could potentially be beneficial by imparting additional structure and strength to the solder joint. Figures 25-28 illustrate the large platelet intermetallic phase observed.

Figure 25: Large Sn/Ag Platelet

Figure 26: Magnified View of Figure 25 Platelet

Figure 27: Large Sn/Ag Platelets in Zone A/B

Figure 28: Solderball Disruption Due to Large Sn/Ag Platelets in Zone A/B

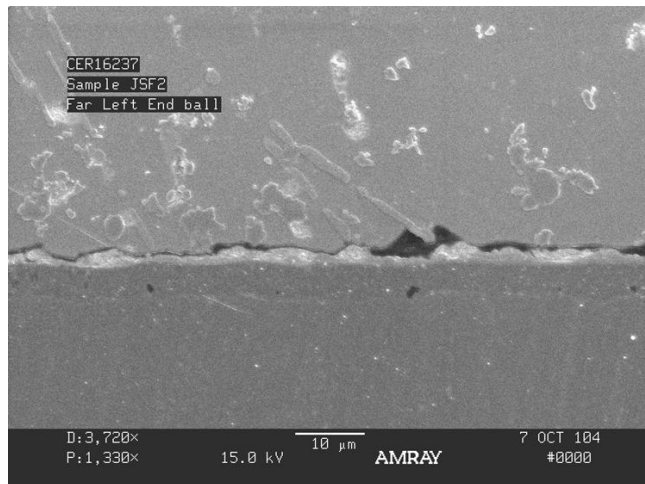
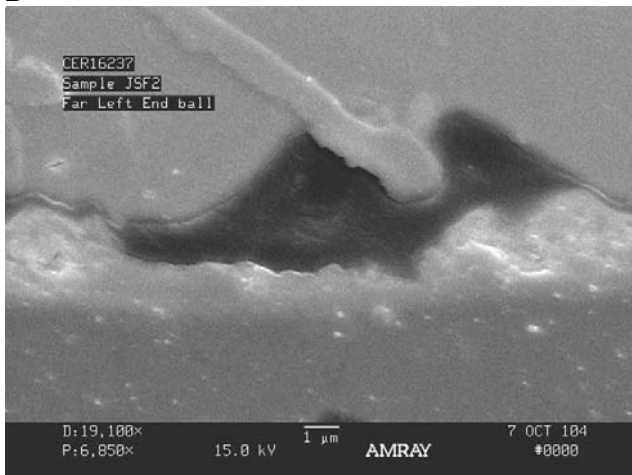
A review of the SEM EDX analysis reveals an interaction of the non-uniform microstructure and the solder joint crack. Figures 29-30 illustrate further evidence of degradation of the BGA solder joint integrity. Figure 30 shows a Sn/Ag intermetallic platelet intercepting a void region along the crack/pwb pad interface. The presence of the Sn/Ag intermetallic platelet intruding into the void space demonstrates the presence of the void during platelet growth or formation of the void upon solder joint solidification – physical evidence of nonwetting/dewetting behavior of the nickel surface during solder joint formation. Soldering nickel surfaces is more complex than soldering copper surfaces due to nickel oxide/flux reactions and the slow diffusion rates of nickel into solder [8]. Secondly, the SEM EDX measurements show that the solder joint microstructure was not uniform. Several industry studies [2, 9, 10, 11] have documented that the formation of a 177°C ternary eutectic alloy (62.5Sn/36.1Pb/1.4Ag) is possible in a mixed surface finish manufacturing scenario. This investigation results show the 177°C ternary eutectic alloy formed in Zones C/D in the interdendritic regions. The

combination of a nickel surface and the non-uniform solder joint microstructure resulted in solder joint degradation leading to solder joint failure. Other industry studies [2, 5, 6, 7, 12] have reported that allowing the formation of a uniform solder joint microstructure with mixed surface finish manufacturing assemblies results in a Pbfree solder joint integrity equal to or better than Sn/Pb solder joint integrity. The non-homogeneous microstructure seen in this study is the result of a Pbfree solderball subjected to a eutectic solder reflow temperatures and lead to solder joint failure.

Figure 29: Solder Joint Crack In Zone

D

Figure 30: Magnified View of Figure 29
